BHI-01384
Rev. 0

105-B Reactor Museum Feasibility Assessment (Phase II) Project

**Prepared for Bechtel Hanford, Inc.,
by MACTEC, Inc.**

June 2000

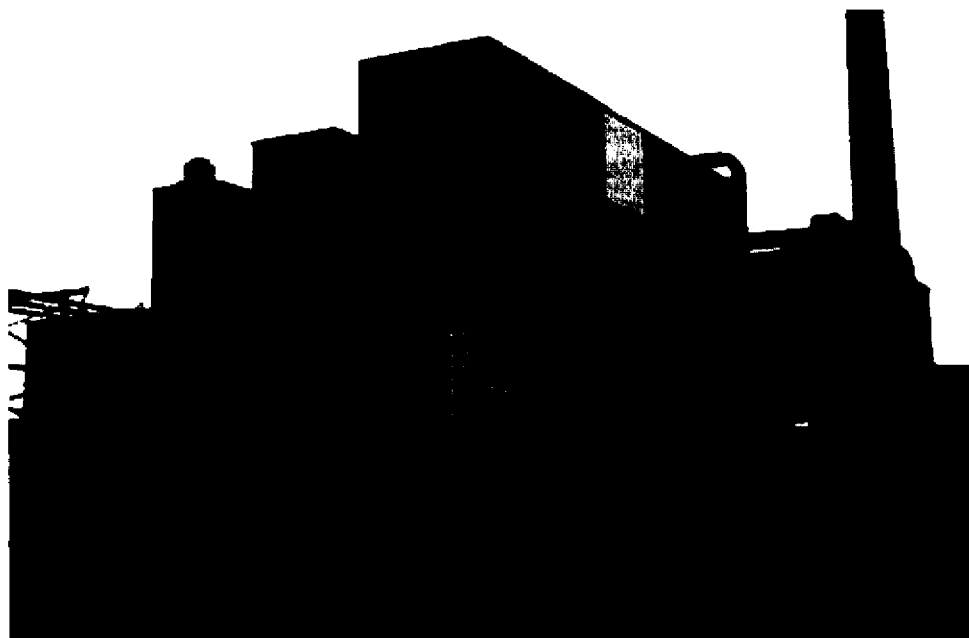
Figure 4-1. B Reactor Entrance and Current Parking Area.

The exterior areas around the building have undergone a considerable number of decommissioning activities over the past several years. As surrounding structures have been removed, the perimeter landscape has been replaced with river rock and crushed-rock material. The primary purpose of these materials is to provide dust control. A small area of asphalt material near the tool/storage area (at the northern entrance) serves as a loading area. The asphalt is very old and has broken apart in many locations. Currently this is the only paved parking area for the building. The parking capacity of the paved area is estimated at about 20 standard-sized automobiles, configured in a conventional parking arrangement. Figure 4-1 shows the front entrance to the B Reactor and the parking area located on the north side of the B Reactor. Two entry doors that provide access to the tour route in B Reactor are depicted in Figure 4-1. The double-door entry on the right side is considered to be the main entrance to be used by tour groups. A second entry door (open door in Figure 4-1) is shown in Figure 4-2. The door steps down to a small concrete walkway, which extends out to the north a short distance.

The original ductwork on the exterior of the building appears to be rusted (see Figure 4-1 and front cover). Although not observed closely from the roof, the structural supports for the ductwork also appear to be rusted. The supports will eventually rust through and the ductwork would fall to the roof. Although the impact force is unlikely to cause any structural damage, falling ductwork would almost certainly damage the roofing and cause additional roof leaks. A more likely condition would be that a wind storm would cause the ductwork to fail, and pieces of the ductwork would become an airborne flying hazard. Although it would not travel far, the flying debris would be a hazard to someone on the ground in the vicinity of the building.

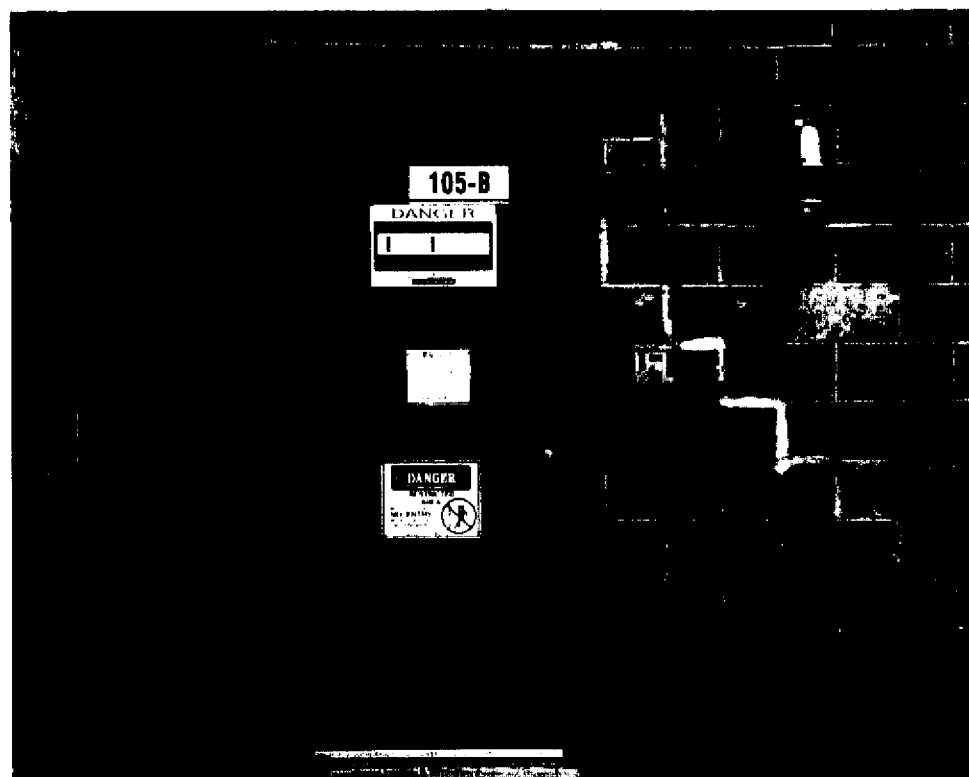
Figure 4-2. B Reactor Entry Door and CMU Deterioration.

Concrete masonry units (CMUs) were used as exterior walls. The steel superstructure is the load-bearing structural component. When originally constructed, the CMU walls did not receive expansion joints to alleviate stresses associated with thermal expansion and contraction. As the weak link in the system, the movement was concentrated on the mortar joints. As a result, numerous cracks have occurred. Many of these cracks were repaired using additional mortar or other rigid materials (Figures 4-2 and 4-5). Each year, new cracks continue to form.

To mitigate hazards and correct deficiencies associated with disabled person accessibility, the small steps at the entry doors on the north side of the B Reactor shall be removed and the transitions at the door thresholds shall be modified to meet ADA accessibility requirements (not to exceed the 0.5-in. maximum transition height). The existing door hardware shall be augmented with panic-exit hardware for ability of egress in case of emergency. An ADA-accessible route is required through these main entry doors. Another exit on the west side of the building (exit is proposed as part of providing emergency egress) also requires similar modifications for compliance with exiting requirements. However, this exit is not required to meet ADA accessibility requirements.

To mitigate the hazards and correct deficiencies associated with materials and construction, non-compliant door hardware along the accessible route shall be replaced. Emergency panic hardware shall be installed at all exit doors. Other door hardware shall remain, if it does not impact providing an accessible route, to preserve the historic character of the building. At the exit doors, the existing wood doors shall be replaced with new hollow metal doors and frames. Custom doors that replicate the appearance of the original doors shall be installed. Mitigating and corrective measures recommended for the roof and walls are discussed in the structural assessment (Section 4.2).

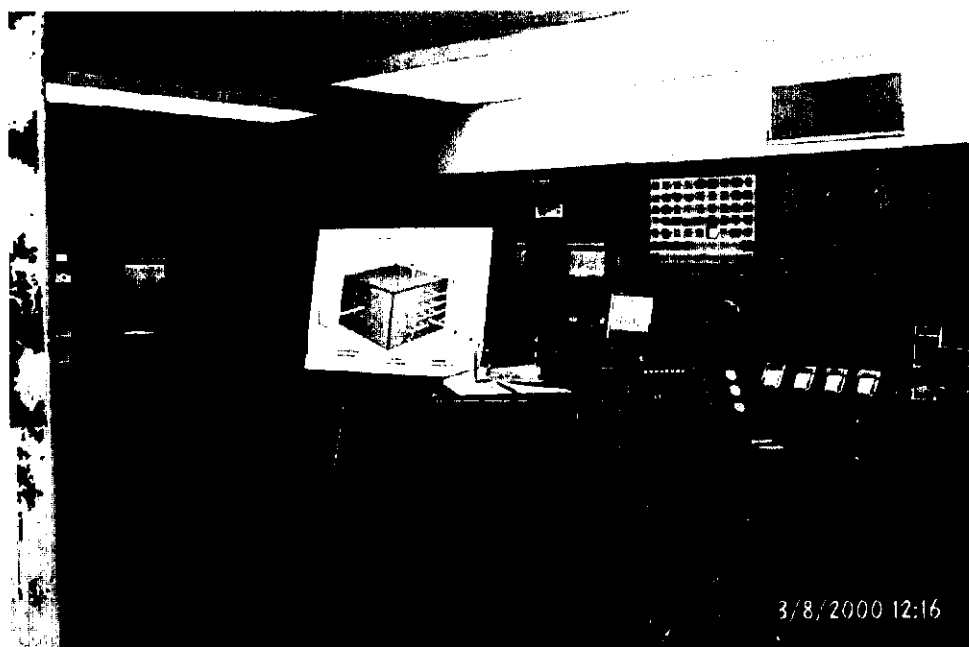
Figure 4-10. Control Room.

It can be assumed that the majority of the paint throughout the facility contains lead. There are a number of areas, including in the control room (see Figure 4-10), where the paint is chipped and peeling. Following the cleaning, any area observed to have flaking or peeling paint shall be painted over with a high-quality, lead-free paint. Subsequent periodic inspections of the paint throughout the facility should be performed to maintain the integrity of the paint in the facility and preclude lead exposures.
